DEPARTMENT OF TRANSPORTATION

Contract #: 04-0120F4Cty: SF/ALA Rte: 80 PM: 13.2/13.9File #: 1.28**WELDING INSPECTION REPORT****Resident Engineer:** Casey, William**Address:** 333 Burma Road**City:** Oakland, CA 94607**Report No:** WIR-028500**Date Inspected:** 26-Sep-2012**Project Name:** SAS Superstructure**OSM Arrival Time:** 700**Prime Contractor:** American Bridge/Fluor Enterprises, a JV**OSM Departure Time:** 1930**Contractor:** American Bridge/Fluor Enterprises, a JV**Location:** Job Site

CWI Name:	William Sherwood and Bernie Docena			CWI Present:	Yes	No	
Inspected CWI report:	Yes	No	N/A	Rod Oven in Use:	Yes	No	N/A
Electrode to specification:	Yes	No	N/A	Weld Procedures Followed:	Yes	No	N/A
Qualified Welders:	Yes	No	N/A	Verified Joint Fit-up:	Yes	No	N/A
Approved Drawings:	Yes	No	N/A	Approved WPS:	Yes	No	N/A
				Delayed / Cancelled:	Yes	No	N/A
Bridge No:	34-0006			Component:	SAS OBG

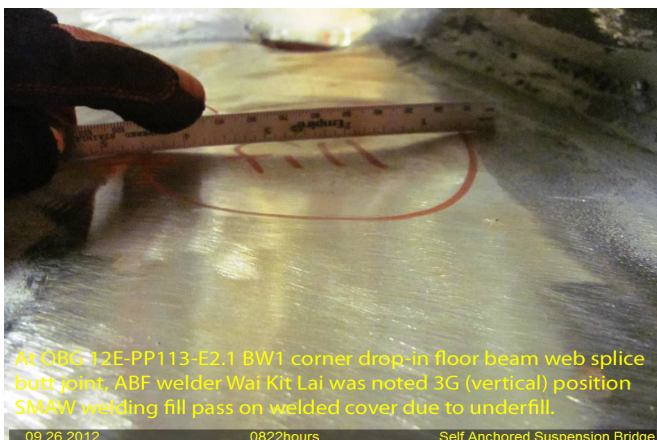
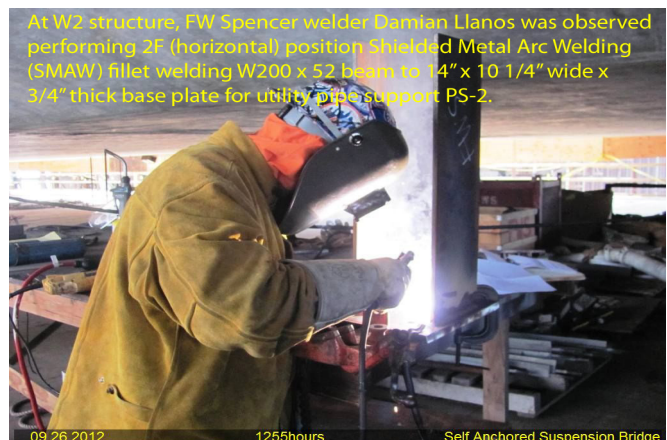
At W2 structure, this QA observed the ongoing fillet welding of the utility pipe support PS-2 per Request for Information (RFI) #2939 of CCO 218. FW Spencer welder Damian Llanos was noted 2F fillet welding the 14" long x 10 1/4" wide x 3/4" thick base plate with four (4) 5/8" diameter drilled holes to W200 x 52 beam. The QC inspection was performed by Steve Jensen utilizing the Welding Procedure Specification (WPS) identified as Fillet Murex to monitor the tack welding and fillet welding to verify the welding parameters. The welding parameters were observed and recorded as 92 and 125 amperes utilizing 2.4 and 3.2mm E7018 electrodes respectively with the welding performed in the 2F position. The 8mm fillet welding all around the W200 x 52 beam to the base plate was completed at the end of FW Spencer shift.

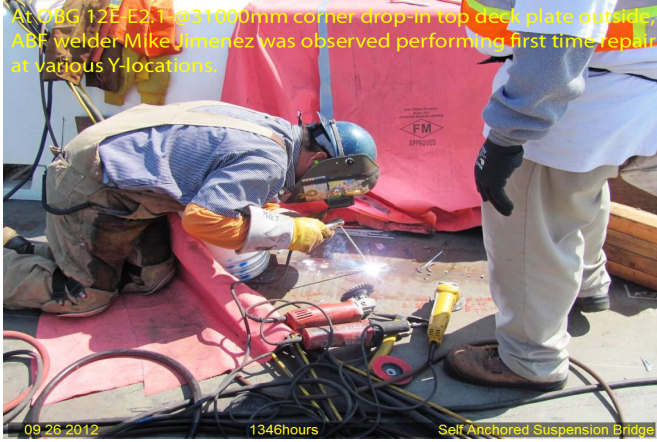
At QBG 12E E2.1 @ 31000mm corner drop-in top deck plate outside ABF welder Mike Jimenez was observed performing first time repair at various Y-locations.
